SLOAN ROYAL OPTIMA PLUS

WITH DUAL FILTERED BY PASS

TROUBLESHOOTING AND MAINTAINING THE OPTIMA PLUS FLUSHOMETER

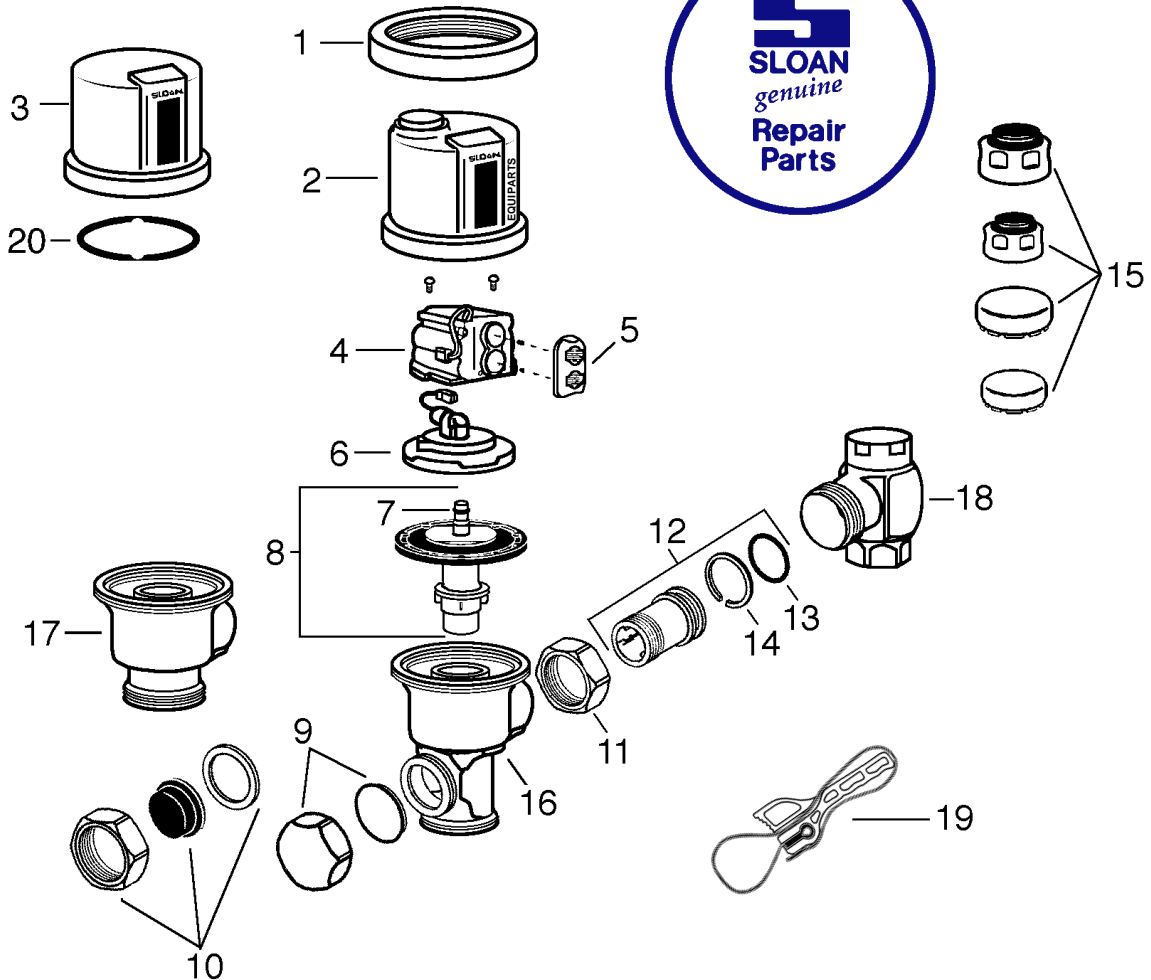
1 # 8421 C.P. LOCKING RING	8 INSIDE PARTS ASSEMBLY	13 # 8037 "O" RING
2 # 8291 PLASTIC COVER W/ BUTTON	# 8285 CLOSET 3.5 GPF	14 # 8038 LOCK RING
# 8399 METAL COVER W/ BUTTON AND LOCKING RING	# 8415 CLOSET 1.6 GPF	# 8419 1" DECORATIVE STOP CAP
3 # 8403 PLASTIC COVER	# 8285 URINAL 3.5 GPF	15 # 8470 3/4" DECORATIVE STOP CAP

# 8393 METAL COVER W/ LOCKING RING	# 8137 URINAL 1.5 GPF	# 8322 1" VANDAL PROOF STOP CAP
4 <i>CALL FOR ASSISTANCE</i> ELECTRONIC MODULE	# 8468 URINAL 1.0 GPF	# 8321 3/4" VANDAL PROOF STOP CAP
5 # 8401 OPTIONAL BEAM DEFLECTOR	9 # 8396 HANDLE CAP - SOLID	16 # SP795 VALVE BODY
6 # 8398 BASE W/ SOLENOID	10 # 8416 HANDLE CAP - DECORATIVE	17 # 8461 VALVE BODY WITHOUT HANDLE OPENING
7 # 8365 QUAD RING	11 # 8040 CP STOP COUPLING	18 <i>CALL FOR ASSISTANCE</i> CONTROL STOP
	12 # 8039 ADJ. TAILPIECE 2-1/16" (OTHER LENGTHS AVAILABLE)	19 # 34727 EC STRAP WRENCH
		CALL FOR TECHNICAL HELP
