SLOAN REGAL

EQUIPARTS MASTER REPAIR PARTS DISTRIBUTOR

TROUBLESHOOTING AND MAINTAINING THE REGAL FLUSH VALVE

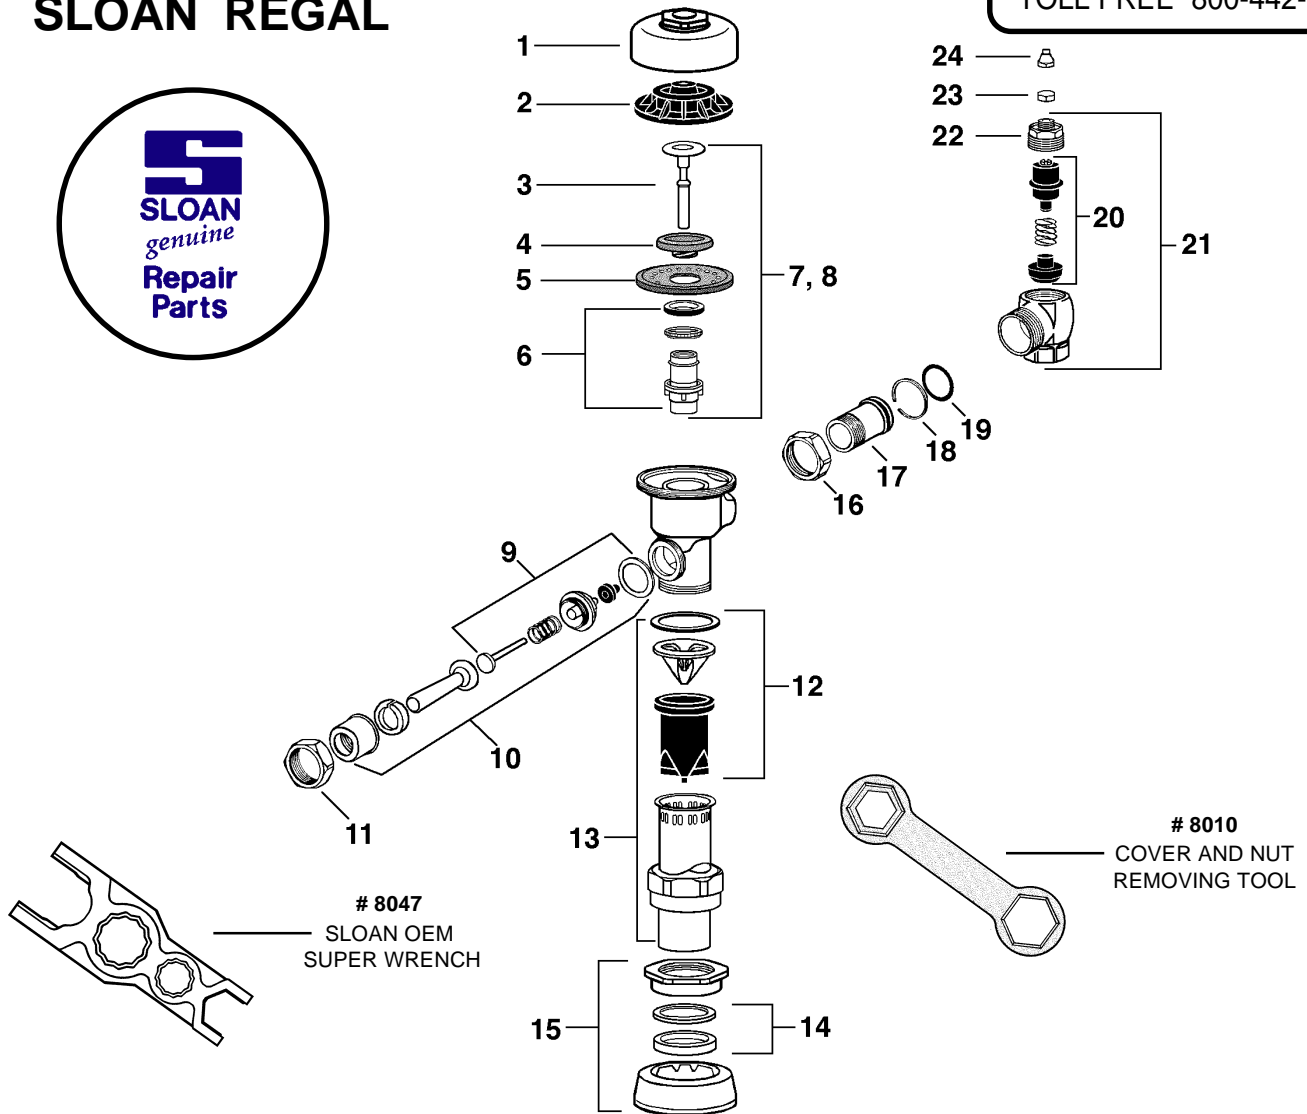
1	# 0000	C.P. COVER				16	# 8040	TAILPIECE NUT
2	# 0000	INSIDE COVER (PLASTIC)				17	# 8039	ADJ. TAILPIECE 2-1/16" (OTHER LENGTHS AVAILABLE)
3	# 8004	CLOSET R. VALVE (WHITE PLASTIC)	A19AC			18	# 8038	LOCKING RING

# 8005	URINAL R. VALVE (BLACK PLASTIC)	A19AU			19	# 8037	"O" RING
	# 8052	CLOSET R. VALVE BRASS (OLD STYLE)				20	# 0000	1" CONTROL STOP REPAIR KIT
4	# 8003	MOLDED DISC	A15A			21	# 00000	1" SCREWDRIVER STOP

# 8002	DIAPHRAGM (COMMON)	A156A				# 00000	3/4" SCREWDRIVER STOP
5	# 8051	DIAPHRAGM (OLD STYLE)				22	# 00000	C. P. BONNET
	# 8053	URINAL R. VALVE BRASS (OLD STYLE)					# 00000	C. P. BONNET
6	# 8006	ADJ. GUIDE	A163A			23	# 00000	C. P. CAP
7	# 8000	CLOSET WATER SAVER KIT				24	# 00000	BUMPER ASSEMBLY
8	# 8001	URINAL RETRO KIT						
9	# 8007	HANDLE REPAIR KIT (PLASTIC)	B50A

# 8043	HANDLE REPAIR KIT (BRASS)						
	# 8008	C.P. HANDLE ASSY.	B32A					
	# 8054	HANDLE NUT						
10	# 8012	V/B REPAIR KIT						
11	CHROME PLATED VACUUM BREAKERS

# 8014	1-1/2" x 9" CLOSET	V500AA					
	# 8015	1-1/4" x 9" URINAL	V500AA					
12	# 8016	3/4" x 9" URINAL	V500AA					
13	# 8020	1-1/2" GASKET KIT						
	# 8021	1-1/4" GASKET KIT

# 8022	3/4" GASKET KIT						
14	# 8017	1-1/2" COUPLING ASSY.						
	# 8018	1-1/4" COUPLING ASSY.						
	# 8019	3/4" COUPLING ASSY.						
CALL FOR TECHNICAL HELP
