SLOAN

ETF-660, 770

TROUBLESHOOTING GUIDE FOR ETF-660 AND ETF 770 SLOAN ELECTRONIC FAUCET

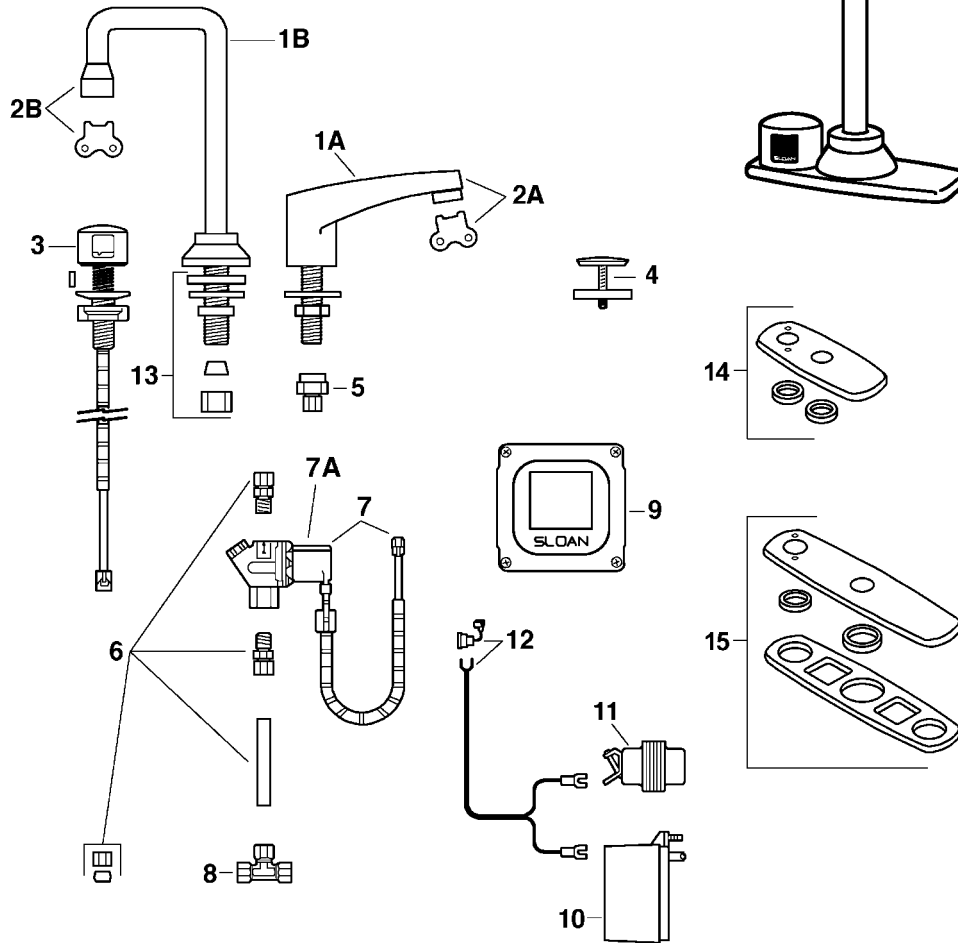
For old-style faucets. ETF-66 and ETF-77 faucets manufactured before 1996 use an # 8462 control module with # 52857 sensor.

1A	# SP4385	Faucet Spout Assembly	6	# 8634	Solenoid Supply Kit
1B	# 51021	Gooseneck Faucet Assembly	7	# 8367	Solenoid Valve Assembly
2A	# 59173	Male Spray Head w/Key - 0.56 gpm		# 8633	Solenoid Valve Repair Kit Includes replacement filter

# 54683	Male Aerator Spray Head w/Key - 2.2 gpm	8	# 54685	Tee Compression Fitting
	# 54702	Male Laminar Flow Spray Head - 2.2 gpm	9	# 8462	Control Module Assembly

# SP4386	Male Spray Head w/Key - 2.0 gpm	10	# 8377	Plug-In Transformer
	# 54693	Key Only	11	# 54688	Box Mount Transformer
2B	# 59857	Female Spray Head w/Key	12	# 54689	Input Power Cable

# 55670	Female Aerator Spray Head w/Key	13	# 54690	Spout Mounting Kit
	# 54677	Female Laminar Flow Spray Head	14	# 54676	4" Trim Plate Kit
	# 54693	Key Only	15	# 54704	8" Trim Plate Kit
3	# 52857	Old Style Sensor Assembly (Obsolete - Use # 8462 & # 52857)	<i>Faucet Cable Extension Cords available on request</i>		
4	# 4625	Cock Hole Cover			
5	# 54687	Tube Fitting Connector

SOLUTION: Replace Sensor. Refer to individual faucet parts diagram for appropriate Sensor Assembly.
